GSFC· 2015

Lessons Learned during the Refurbishment and Testing of an Observatory after Long- term Storage

John Hawk, Sharon Peabody, and
Richard Stavelly
NASA Goddard Space Flight Center

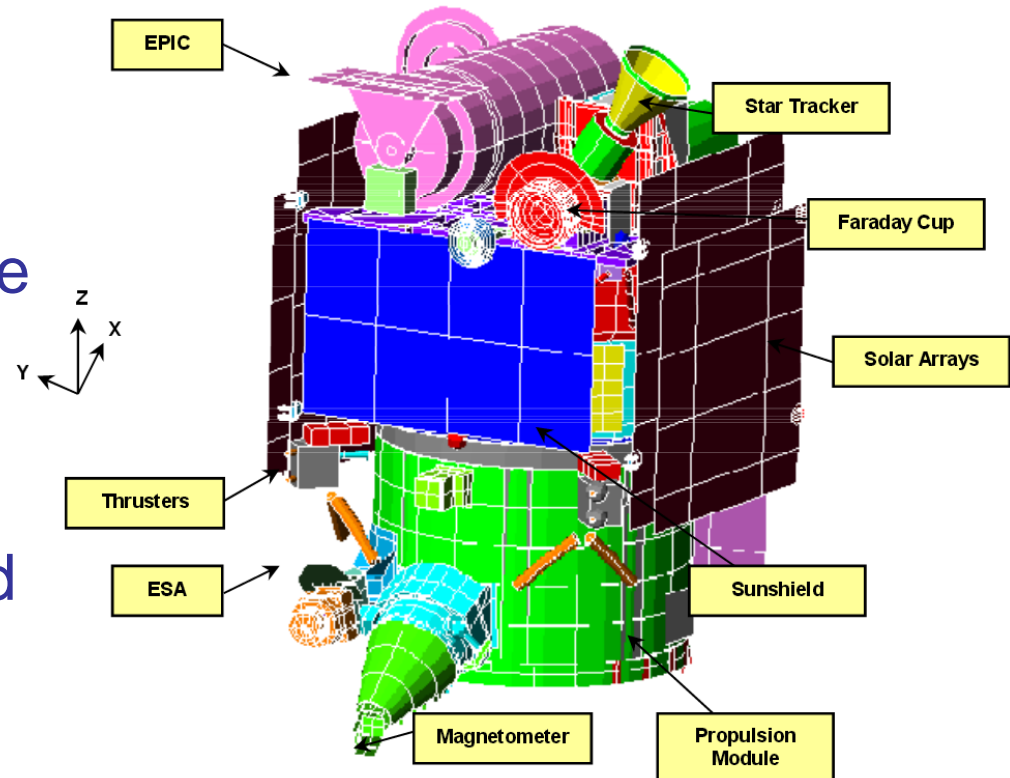
The thermal models were originally built in Thermal Synthesizer System (TSS) and SINDA/FLUINT, but were rebuilt in Thermal Desktop using the existing thermal models and available documentation for the rebuild process.

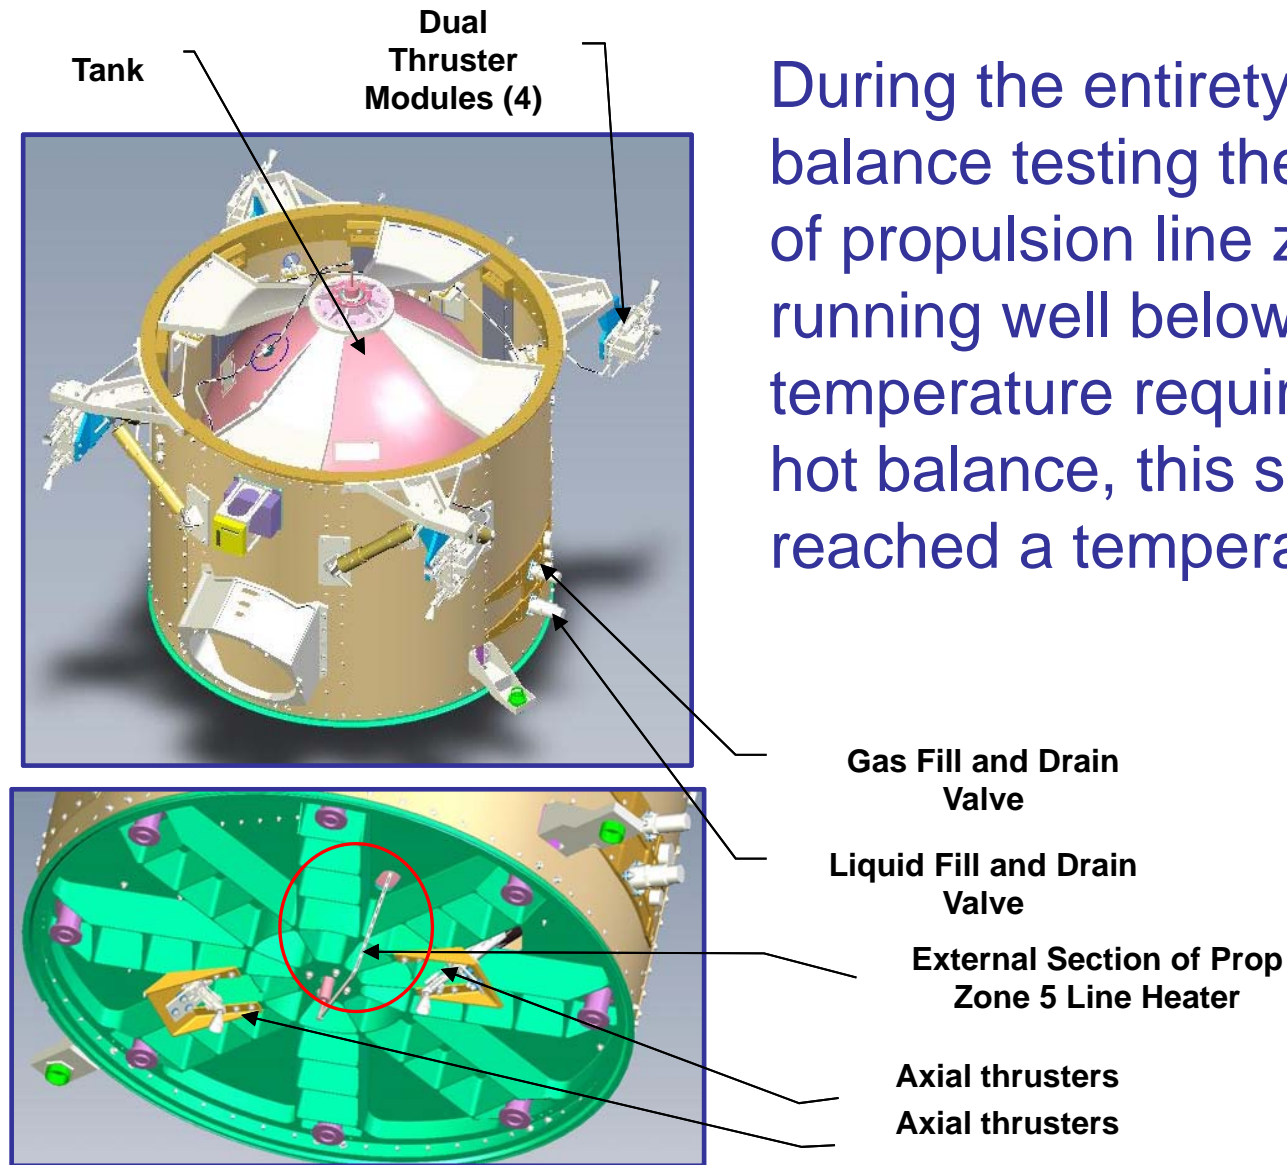
Propulsion - Module Hardware

During the entirety of the thermal balance testing the external run of propulsion line zone 5 was running well below the minimum temperature requirement. During hot balance, this section of line reached a temperature of +2.3°C.

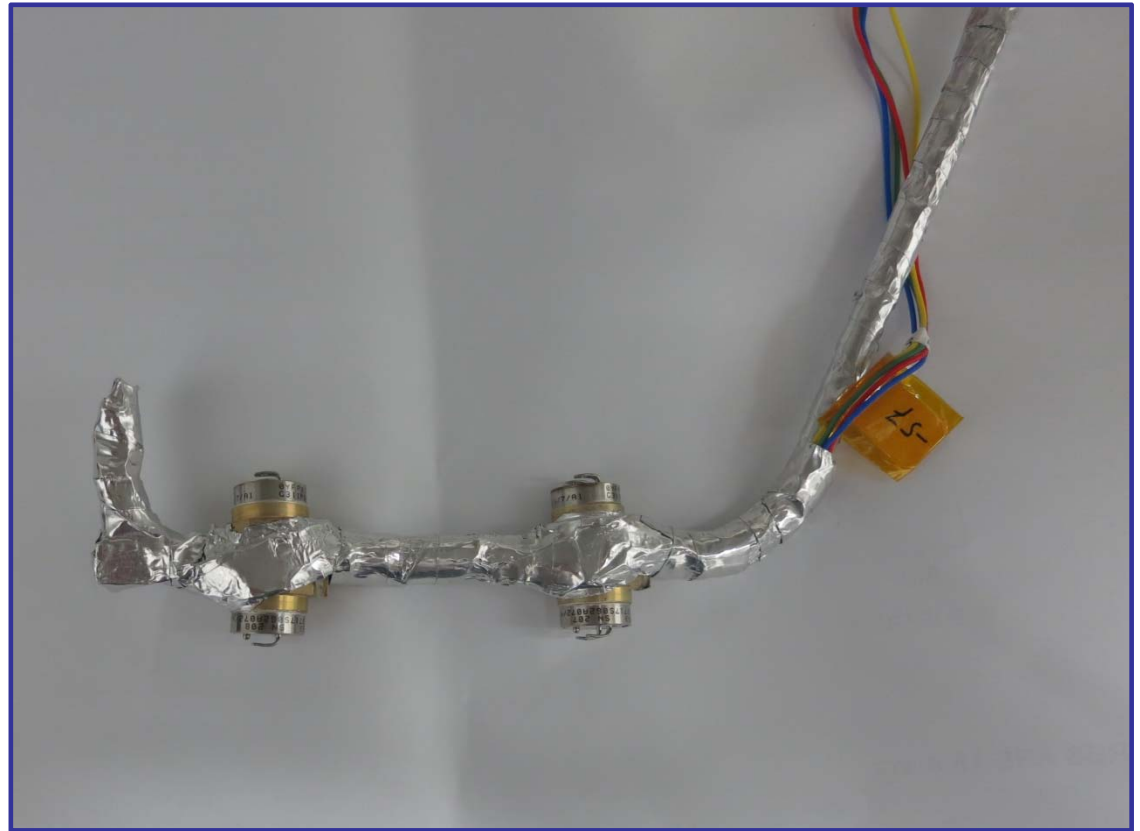
- Since there was no readily available flight experience with this layered construction, an Engineering Development Unit (EDU) was fabricated and tested.
- Ambient testing of the flight installed auxiliary heater, as well as the underlying existing heater, was performed to verify operation.

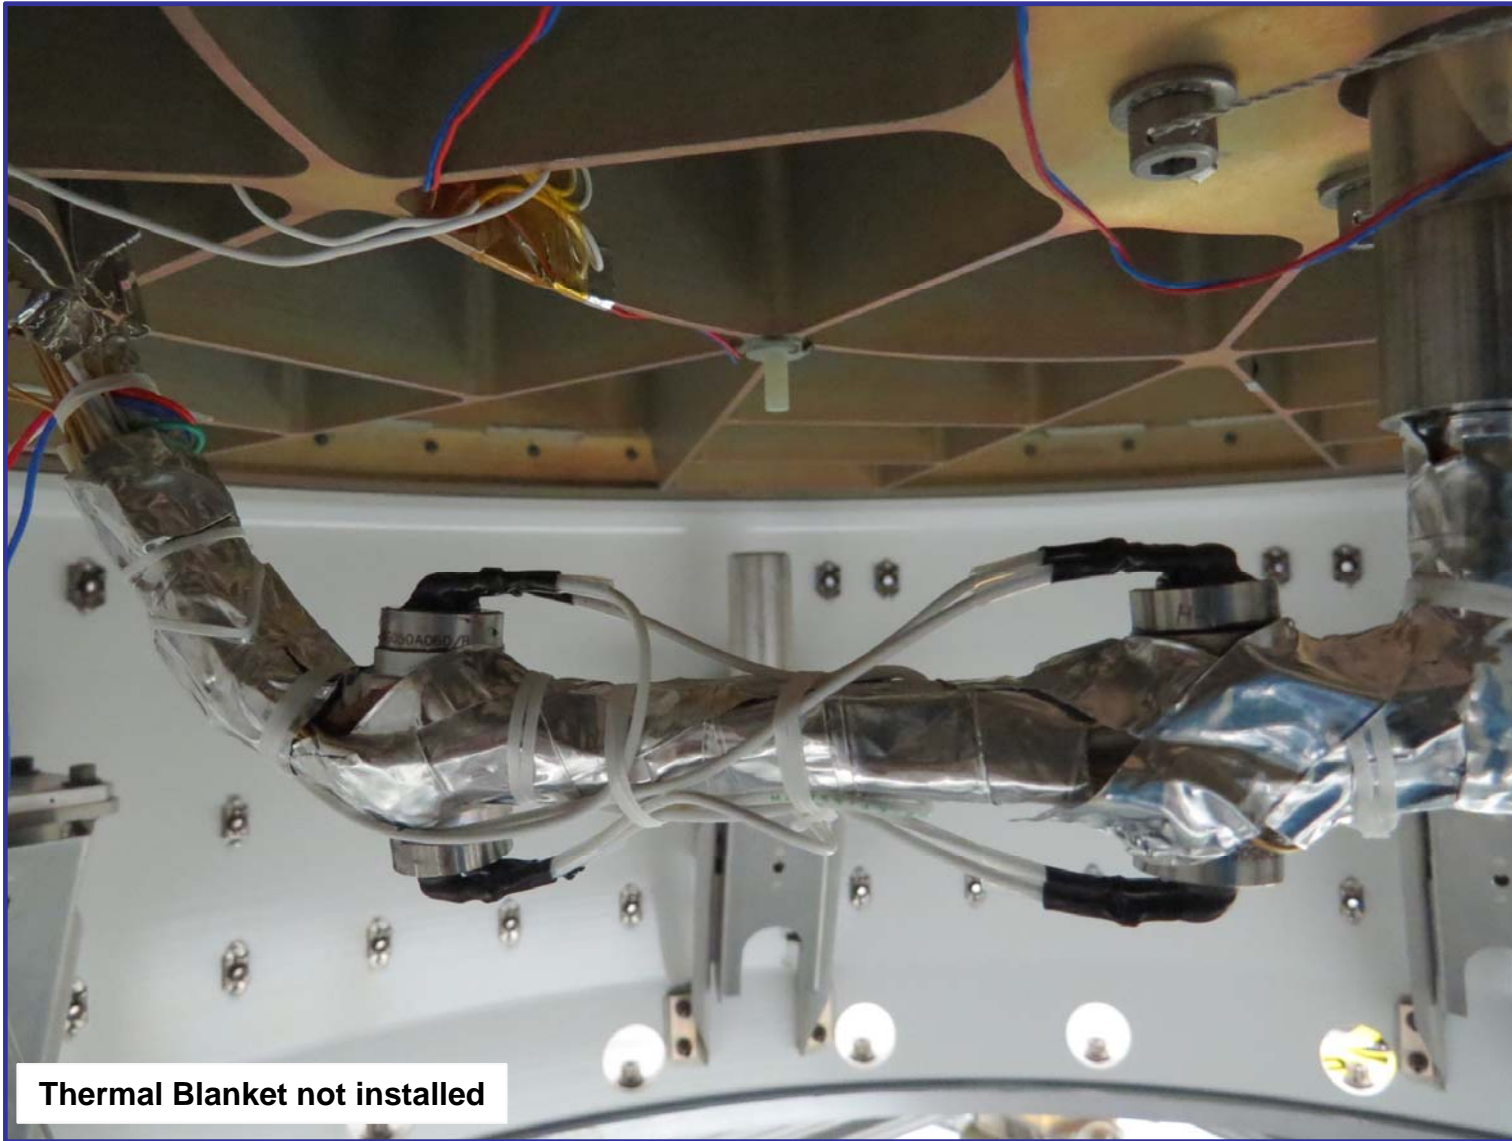
Propulsion - Flight Installed Auxiliary Heater

- Wires had to be run to the bottom of the propulsion module to power the flight auxiliary heater.
- The high gain antenna and the prop module access panel had to be removed to gain access to the inside of the prop module for wire routing.
- Several mli blankets had to be removed to install the auxiliary heater.
- The flight installation had to be tested.

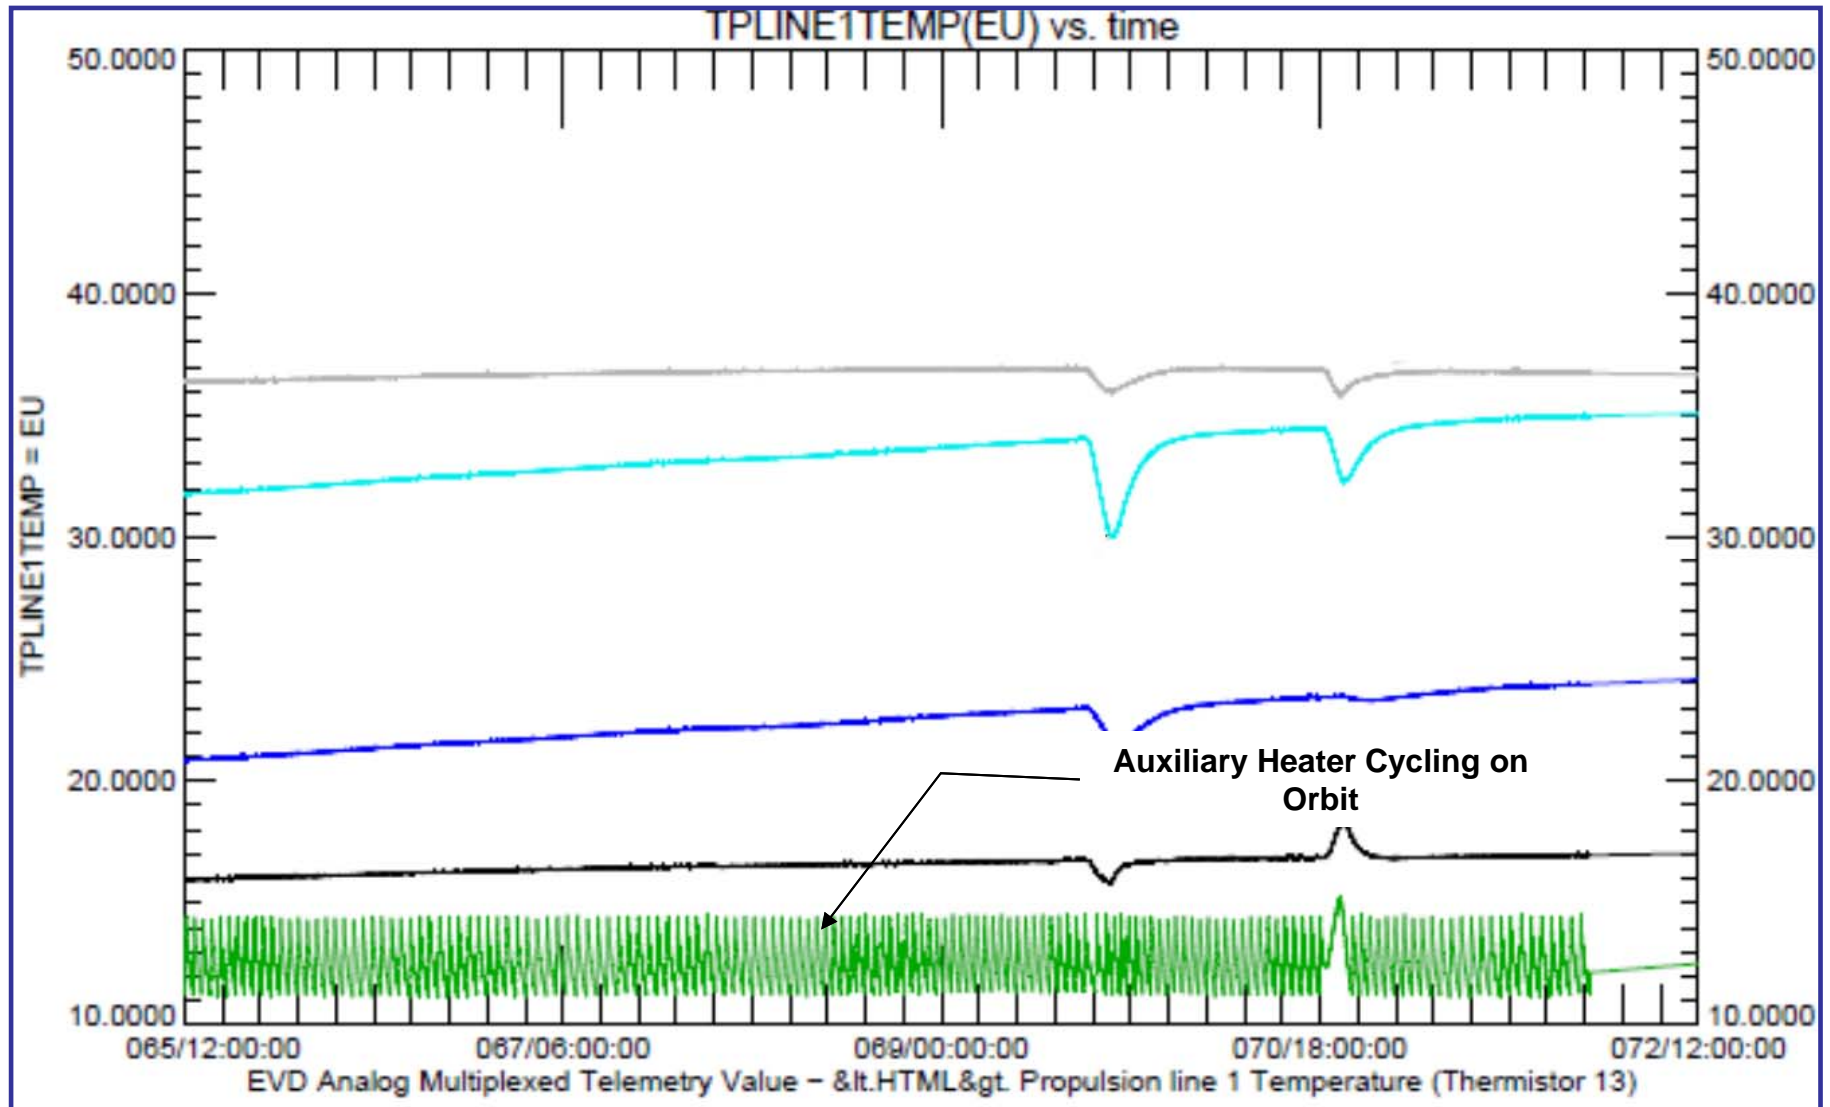
Propulsion - Auxiliary Heater Flight Data

- *The successful test program demonstrated acceptable function of the additional heater and thermostats, while preserving the functionality of the underlying heater.*
- *When possible separate propulsion line heater zones should be installed on interior and exterior lines.*
- *If a propulsion line heater zone spans the interior and exterior interface of a spacecraft use doublers to enhance longitudinal conduction and locate control sensor at the coldest section of line.*

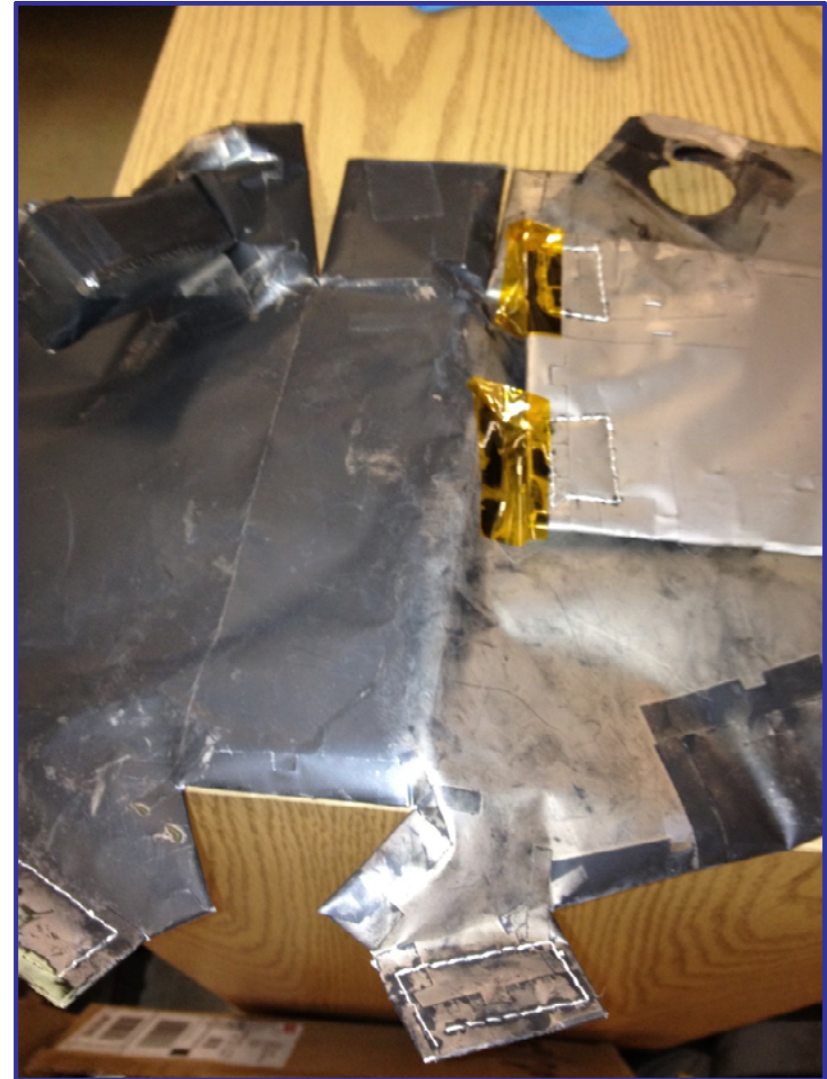
- Germanium missing from most areas of germanium black Kapton MLI; replaced outer layers.
- Several blankets totally missing.
- Had to figure out the original location of many others.

- *MLI in long term storage should be in a humidity controlled environment and handling minimized.*
- *Thermal Project Engineer should understand and inform Project Management regarding the scope and complexity of thermal blanket fabrication and installation.*
- *Individual blanket designs and fabrications should be identified with sufficient time allocated for these activities in the I&T schedule.*
- *Individual blanket installations should be identified in the I&T schedule as any other hardware installation task, rather than specifying a general time period for overall installations.*

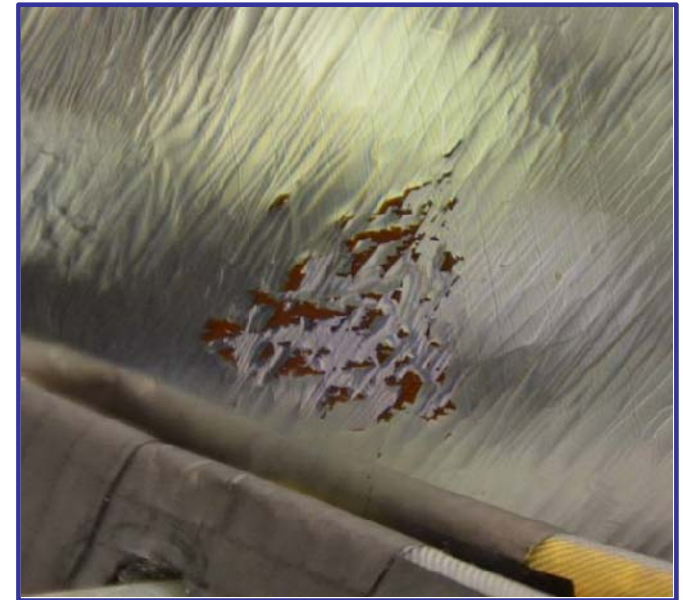
- Most thermal control surfaces showed damage due to mishandling, although the optical properties hadn't changed during storage.
 - NS43C white coatings touched up with Z93C55 white paint.
 - High temperature E-glass MLI near the thrusters were shedding particles; required stainless steel shells be installed to contain the particles.
 - Phosphoric-acid etched nickel inside the NISTAR baffles began flaking. Instrument was taken apart, surfaces stripped and recoated with Z306 black paint.
 - Root cause of shedding not clear.

- *Schedule and budget for increased cleanings and inspections of coatings throughout the I&T campaign.*
- *Early on in the refurbishment consider stripping and re-applying coatings to all shedding surfaces.*
